AMD

Mauro Lourenco tells us about acid mine drainage, and the secondary impacts associated with its treatment

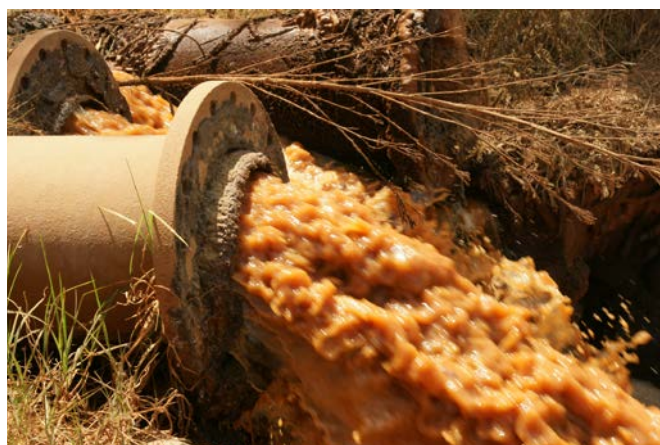
The distinctive orange colour of acid mine drainage is due to ‘yellowboy’, a precipitate composed mainly of iron(III) hydroxide, also known as ferric hydroxide.

‘Yellowboy’, or ferric hydroxide, is a yellow-orange solid that precipitates out and discolours water. It is damaging to

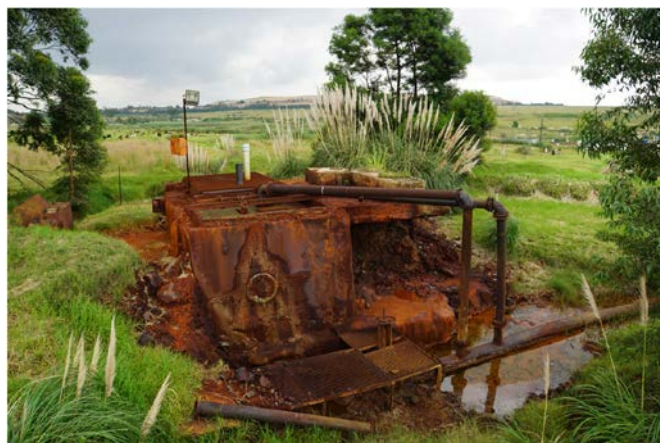
The Tweeloopiesspruit decant point in the Witwatersrand Western Basin in February 2017. Here the 'yellowboy' precipitate is a darker orange-brown colour.

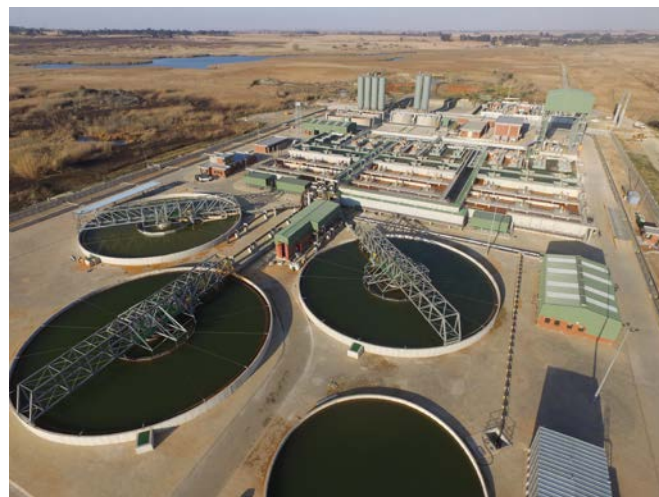
The Eastern Basin AMD treatment plant, designed by AECOM for the Trans Caledon Tunnel Authority (TCTA), is one of the largest high-density sludge (HDS) plants in the world, with a maximum treatment capacity of 110 ML/d.

The water is first mixed with limestone (CaCO_3) as a pre-neutralisation step, and then agitated and aerated to oxidise the ferrous iron and manganese. Lime (Ca(OH)_2) is added to raise the pH further, followed by polymers that act as flocculating agents – causing solid particles to aggregate – in the gypsum crystallisation tank. Here, metals precipitate as metal hydroxides, while sulphate ions and calcium ions form gypsum ($\text{CaSO}_4 \cdot 2\text{H}_2\text{O}$). In the thickeners section, the effluent is clarified as the solids are settled out as a sludge consisting of metal hydroxides and gypsum. Some of the sludge is recycled back to the start of the process to aid neutralisation and precipitation, and the rest disposed down the old Grootvlei No. 1 shaft. The treated effluent is discharged into the Blesbokspruit.

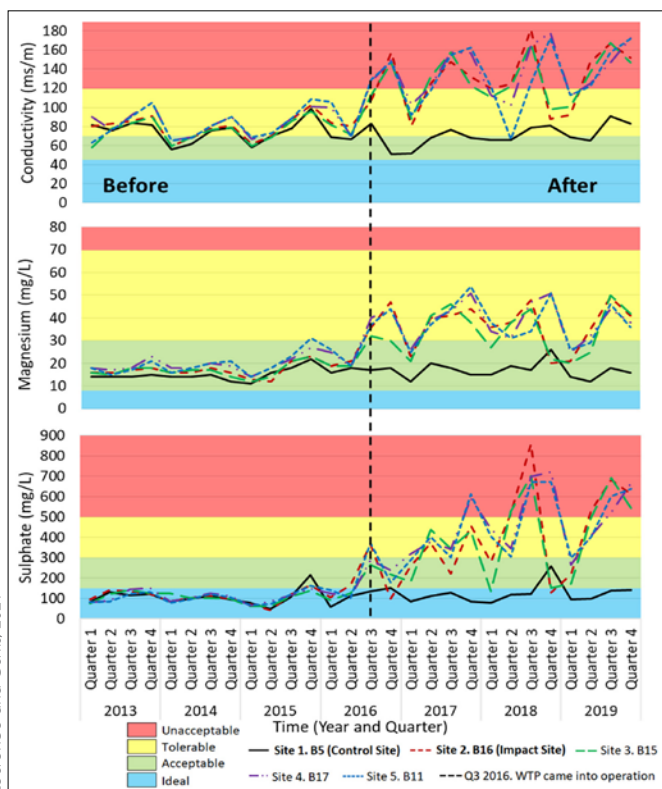
Time-series charts for conductivity, magnesium and sulphate monitored by Rand Water at Blesbokspruit sites for the period 1 January 2013 to 31 December 2019. The colours on the charts correspond to the Blesbokspruit Forum water quality guidelines for each specific variable. The dashed black line indicates the quarter in which the treatment plant came into operation (Q3 2016).

I researched the influence of the new treatment plant on the Blesbokspruit wetland for my MSc degree, awarded by the School of Geography, Archaeology and Environmental Studies at the University of the Witwatersrand. An analysis of data from Rand Water, which conducts regular sampling at a number of sites within the wetland as part of a monitoring programme, shows that all the sites had similar seasonal patterns of conductivity, magnesium and sulphate levels before the AMD treatment plant came into operation. After the treatment plant started, however, these parameters increased dramatically at sites 2, 3, 4 and 5, which are all downstream of the plant, and conductivity and sulphate have reached unacceptable levels. Site 1 is upstream, so it does not show evidence of changing water quality through time.

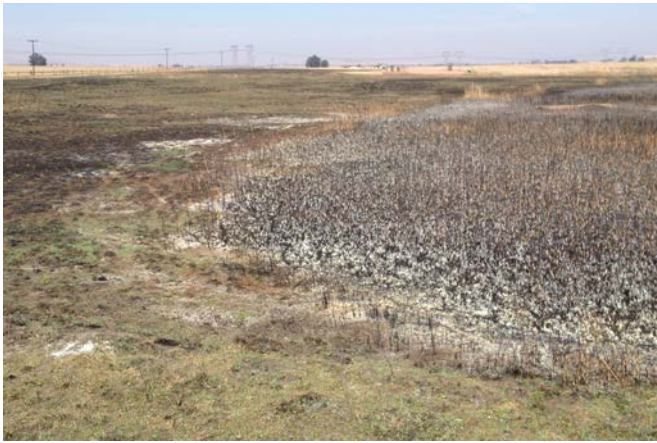
At Marievale Bird Sanctuary downstream of the treatment plant, salt crusts can be seen on soil surfaces where highly saline water has evaporated.

The evidence of a highly saline environment downstream of the treatment plant are clear to all who visit Marievale Bird Sanctuary, as salt crusts can be observed on soil surfaces where water has evaporated. Highly saline environments are not only potentially damaging to species that cannot tolerate the salty conditions, but the Blesbokspruit is also a tributary to the Vaal River System, an important water source. Although the Blesbokspruit joins the Vaal River below the Vaal Dam, which is the main drinking water supply for the people of Gauteng, water already has to be released periodically from the Vaal Dam in order to dilute

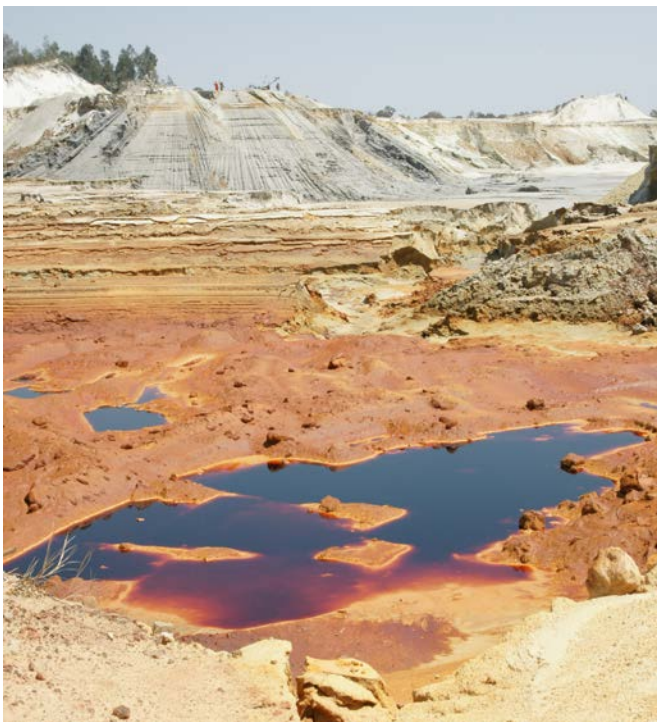
Acid drainage also flows from tailings – the ore residues after mineral processing – and in South Africa this is typically referred to as acid rock drainage (ARD).

What's more, as ore material from underground is brought to the surface for processing, mines typically store the ore waste – called tailings – in a tailings dam or mine dump. The tailings material is exposed to the elements, resulting in further oxidation and acidity generation.
